## Windstorm Mitigation Report

Lake Tarpon Sail and Tennis Club Condominium

Tarpon Springs, FL

As of 04-03-2025 | FPAT File# MUD2523259

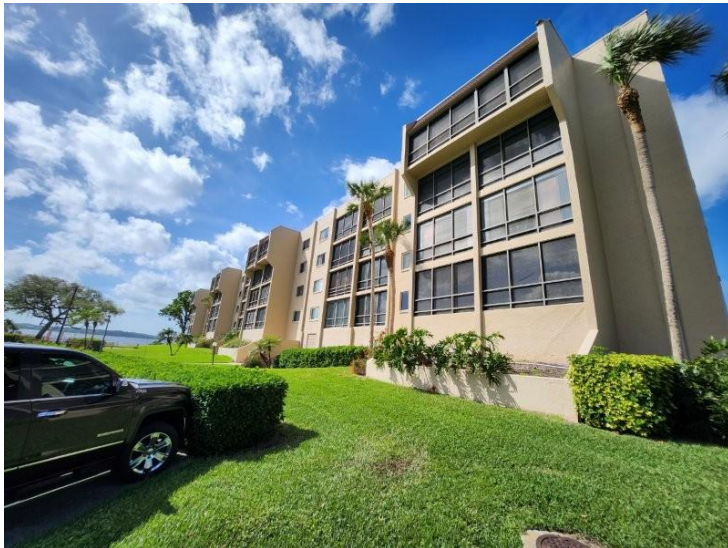
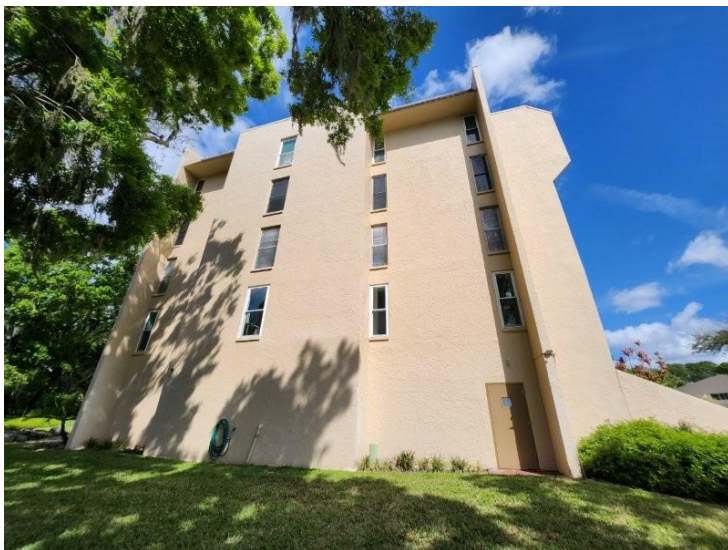
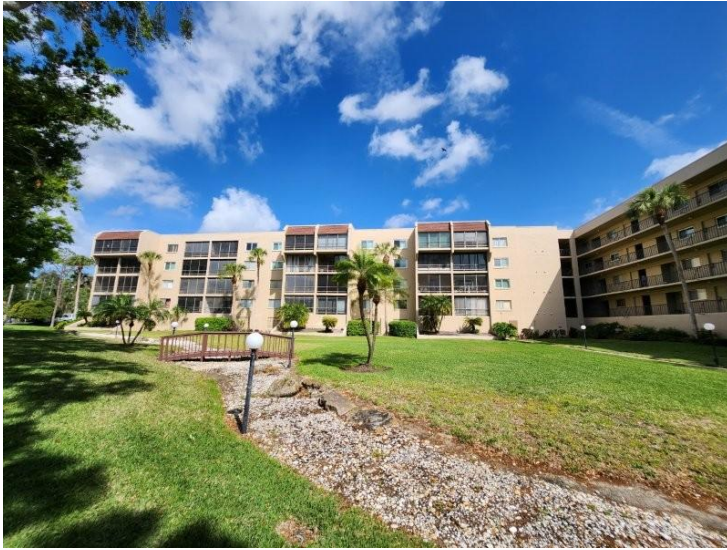
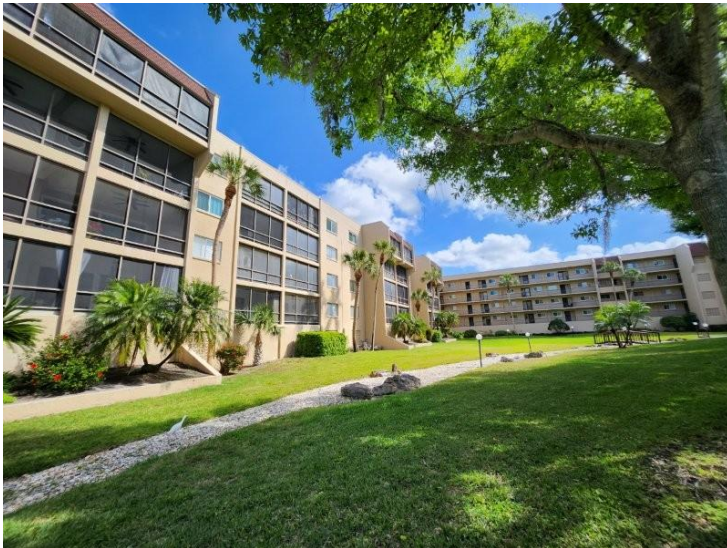
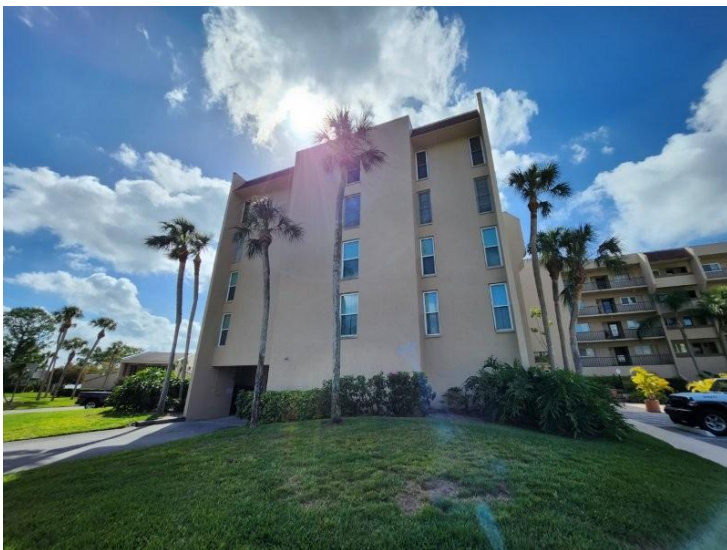
Exterior Elevation

| <b>5. Roof Geometry:</b><br>Comments: | <b>Flat Roof</b><br>Inspection verified flat roof shape, refer to attached photographs. |
| <b>7. Opening Protection:</b><br>Comments: | <b>None or Some Glazed Openings</b><br>Inspection verified some impact rated opening protection. Not all glazed openings were protected with impact resistant coverings. |

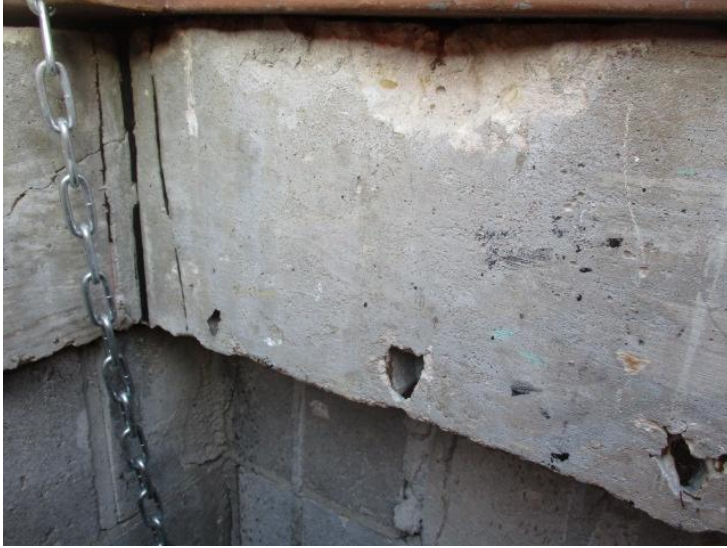
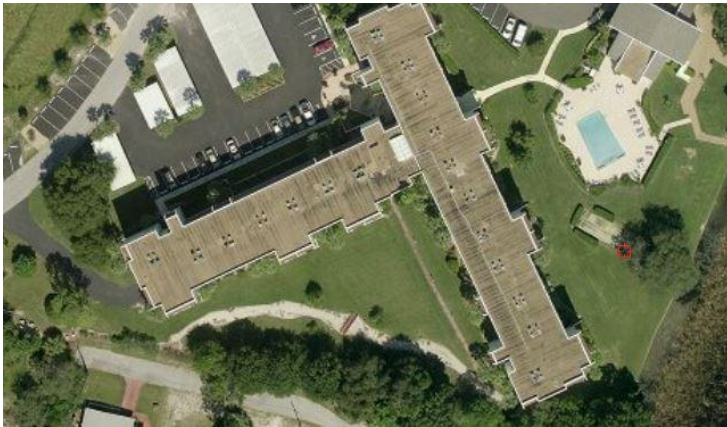
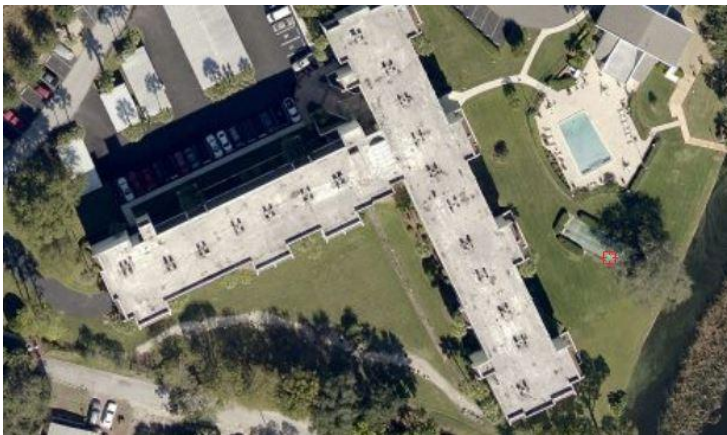
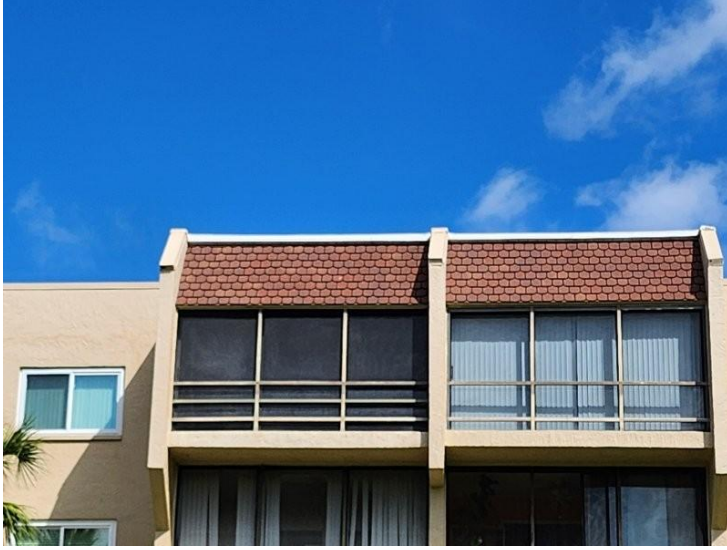
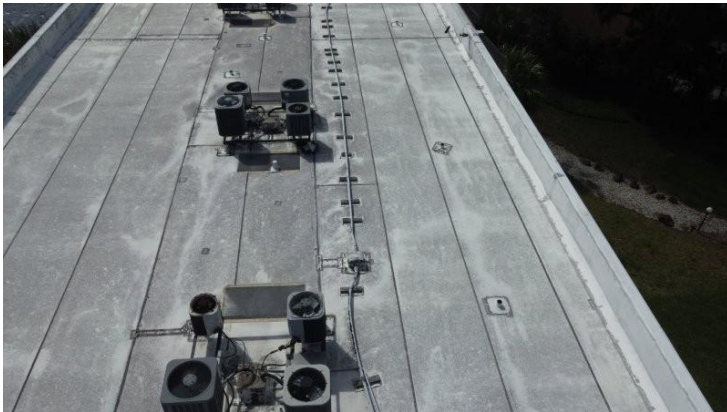
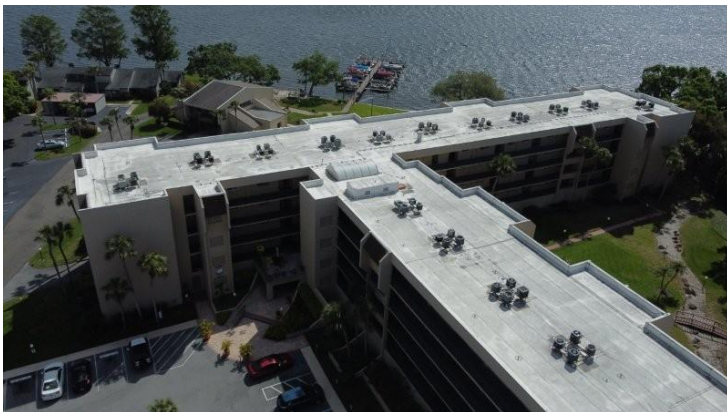
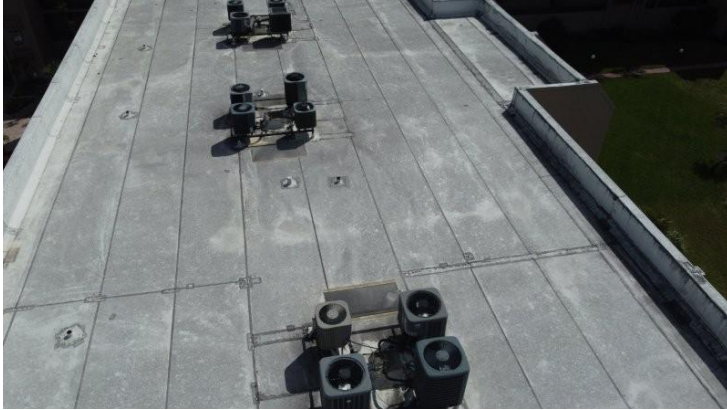
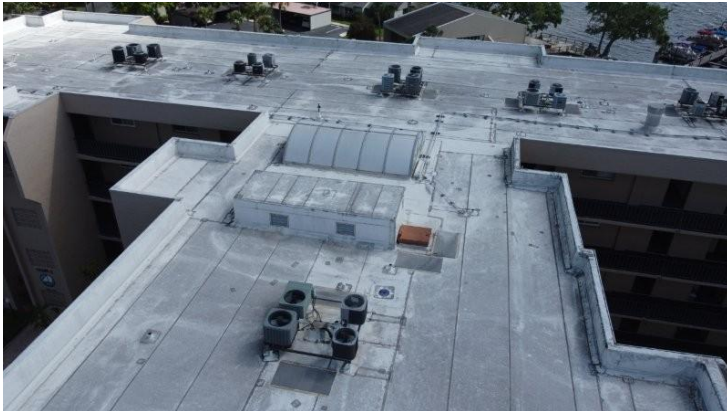
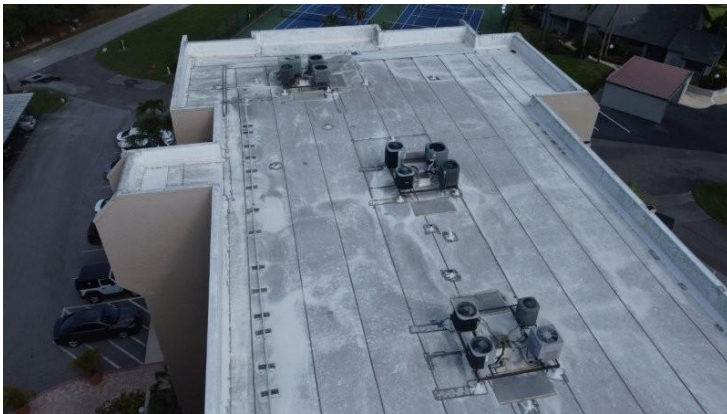
Roof Construction

| <b>2. Roof Covering:</b><br>Comments: | <b>FBC Equivalent</b><br>We were unable to locate a roofing permit with the local building department; however, in our professional opinion the roof covering was replaced between 2011-2012. The roof covering replacement was confirmed via historical imagery provided by Pictometry. This roof was verified as not meeting the building code requirements outlined on the mitigation affidavit. |
| <b>3. Roof Deck Attachment:</b><br>Comments: | <b>Reinforced Concrete Roof Deck</b><br>Inspection verified a roof structure composed of cast-in-place or pre-cast structural concrete designed to be self-supporting and integrally attached to the wall / support system. |
| <b>4. Roof to Wall Attachment:</b><br>Comments: | <b>Structural</b><br>Inspection verified a roof structure composed of cast-in-place or pre-cast structural concrete designed to be self-supporting and integrally attached to the wall / support system. |
| <b>6. SWR:</b><br>Comments: | <b>No</b><br>No SWR verified. |

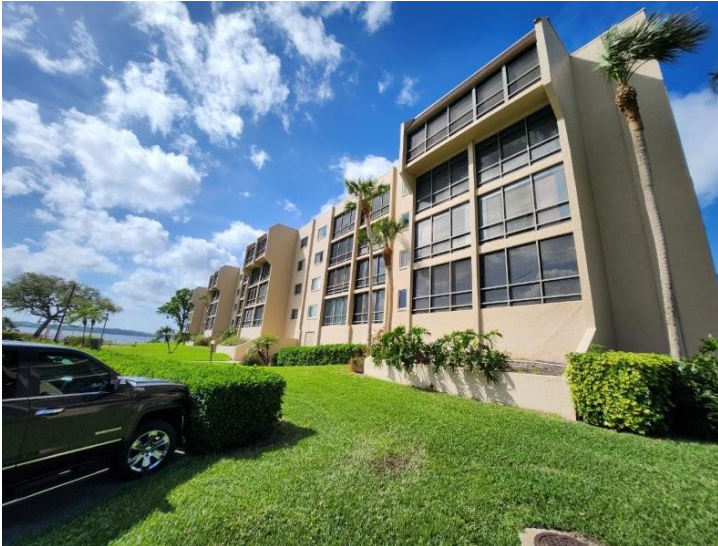
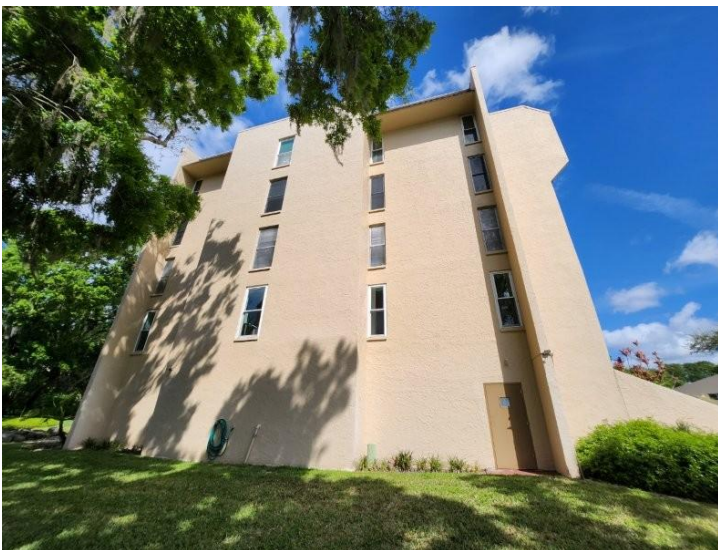
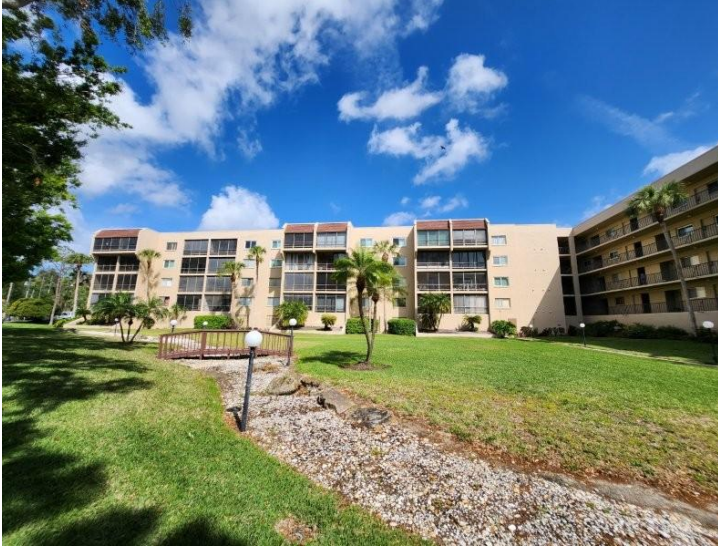
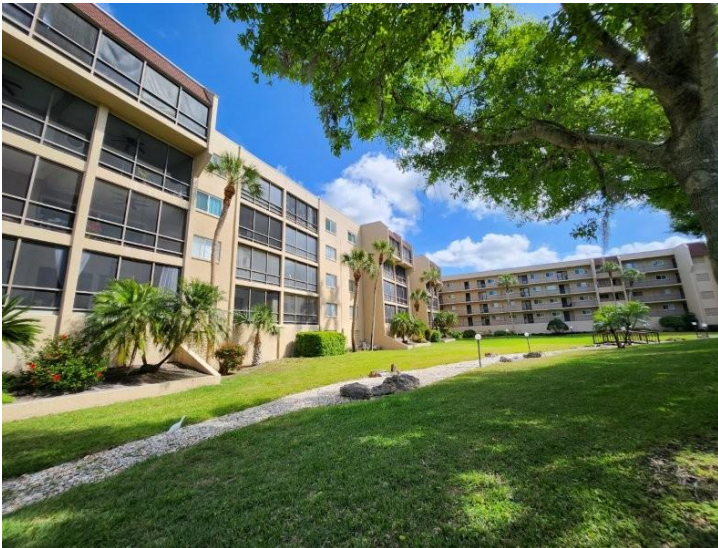
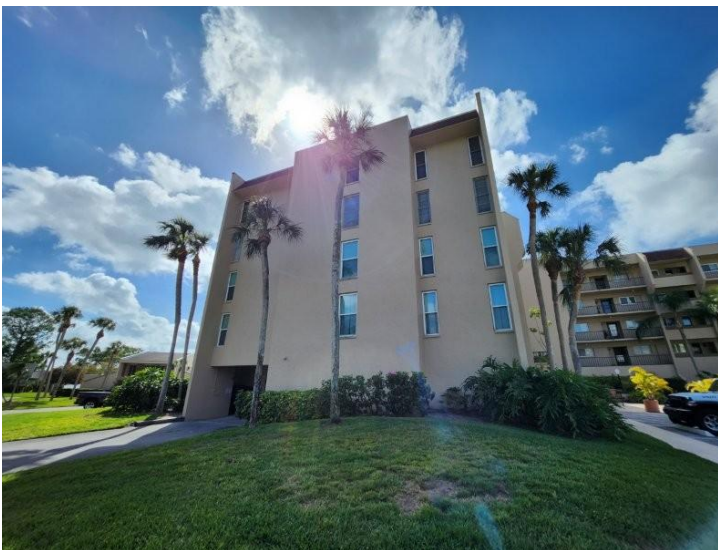
Exterior Elevation

| <b>4. Opening Protection:</b><br>Comments: | <b>None or Some Glazed Openings</b><br>Inspection verified some impact rated opening protection. Not all glazed openings were protected with impact resistant coverings. |

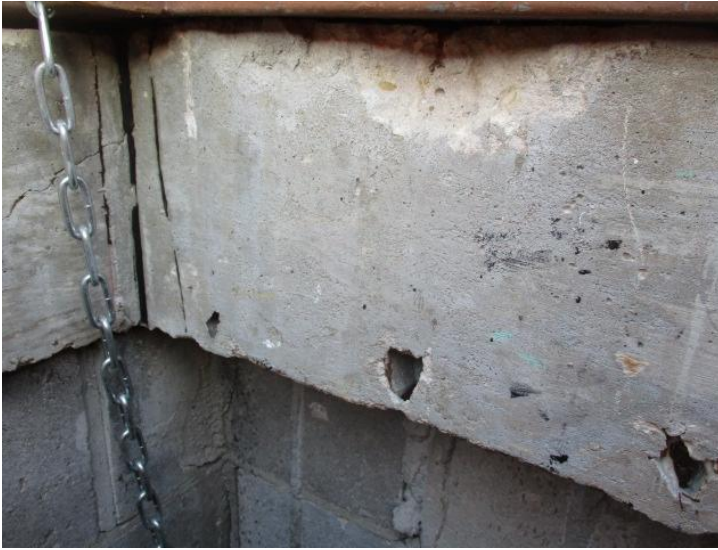
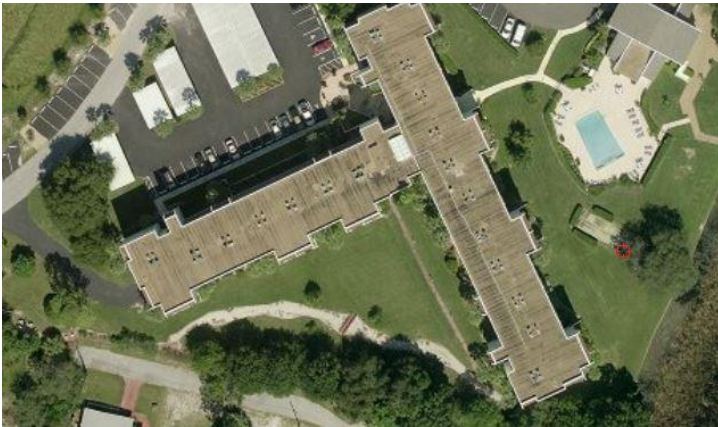
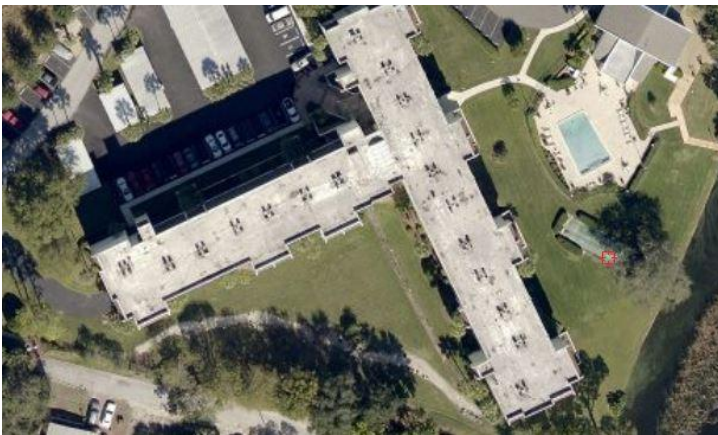
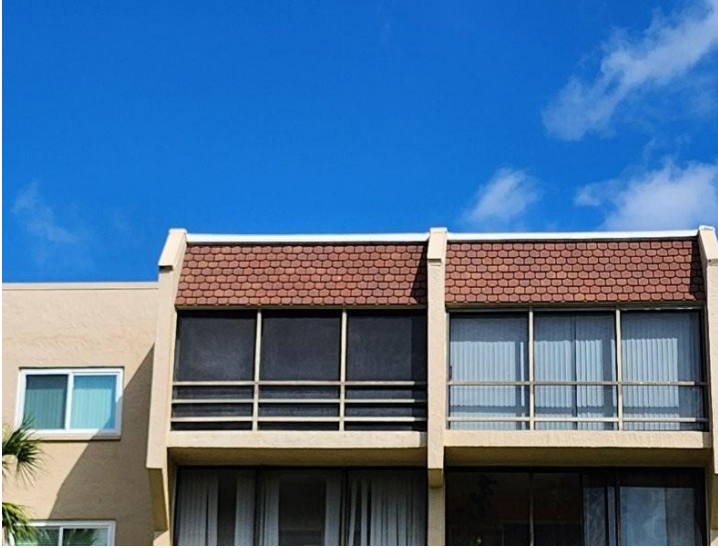
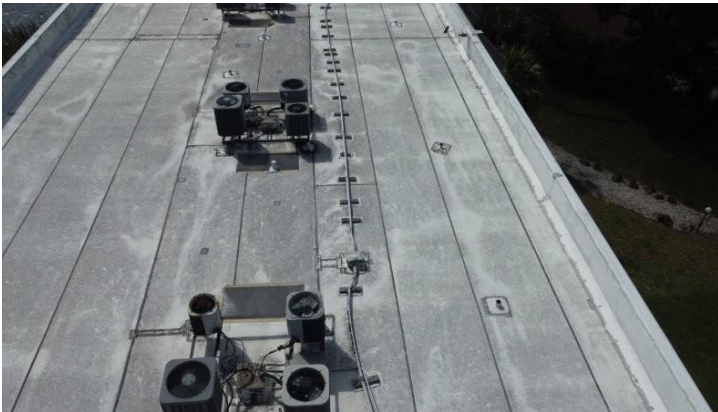
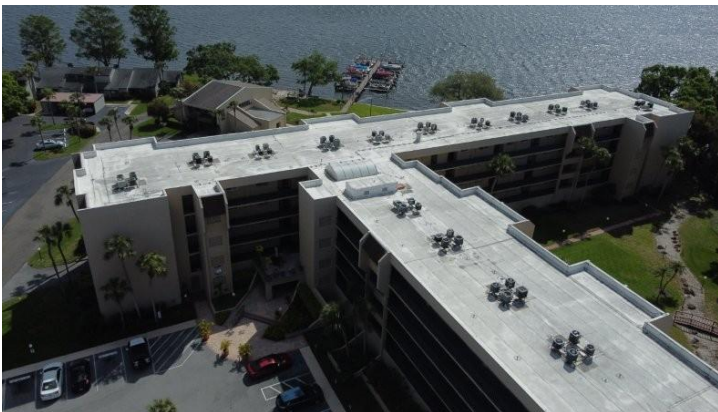
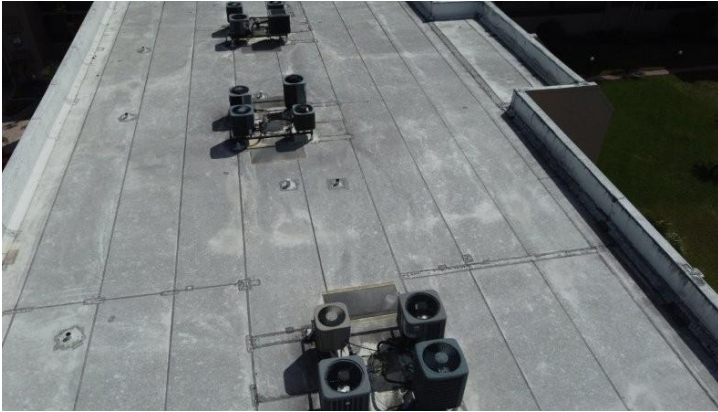
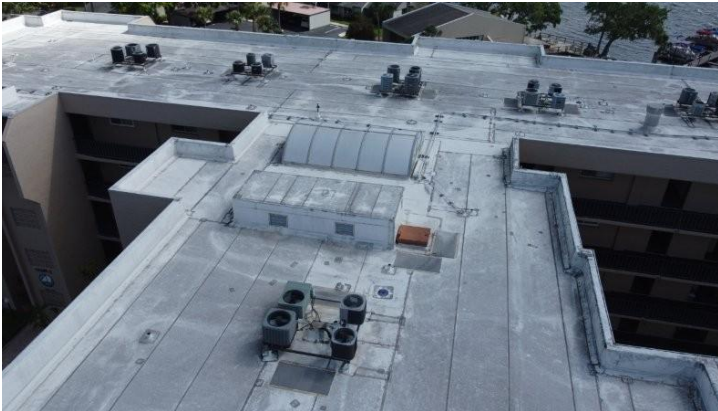
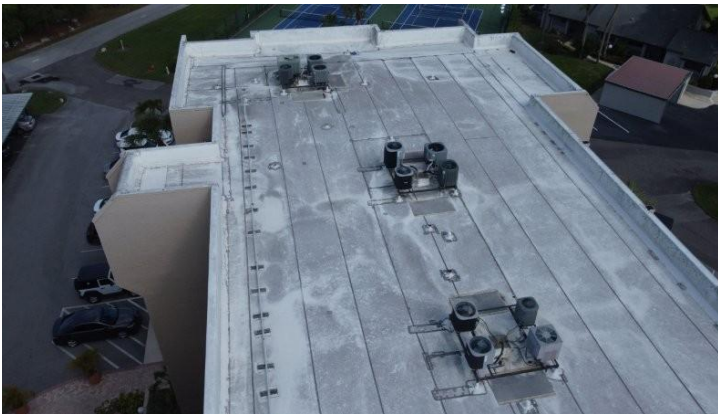
Roof Construction

| <b>1. Roof Covering:</b><br>Comments: | <b>FBC Equivalent</b><br>We were unable to locate a roofing permit with the local building department; however, in our professional opinion the roof covering was replaced between 2011-2012. The roof covering replacement was confirmed via historical imagery provided by Pictometry. This roof was verified as not meeting the building code requirements outlined on the mitigation affidavit. |
| <b>2. Roof Deck Attachment:</b><br>Comments: | <b>Reinforced Concrete Roof Deck</b><br>Inspection verified a roof structure composed of cast-in-place or pre-cast structural concrete designed to be self-supporting and integrally attached to the wall / support system. |
| <b>3. SWR:</b><br>Comments: | <b>No</b><br>No SWR verified. |
