Windstorm Mitigation Report (OIR-B1-1802)

Lake Tarpon Sail and Tennis Club Condominium Association, Inc.
90 S Highland Ave, Units 1101-1418
Tarpon Springs, FL 34689

As of 04-03-2025 | FPAT File# MUD2523259

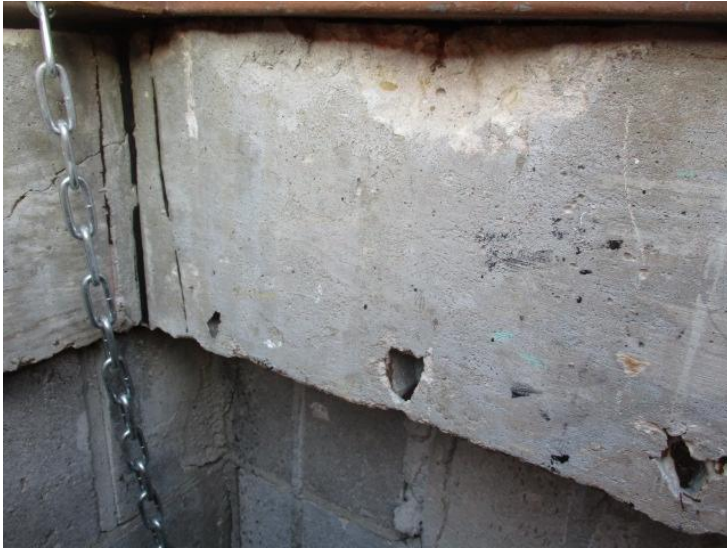
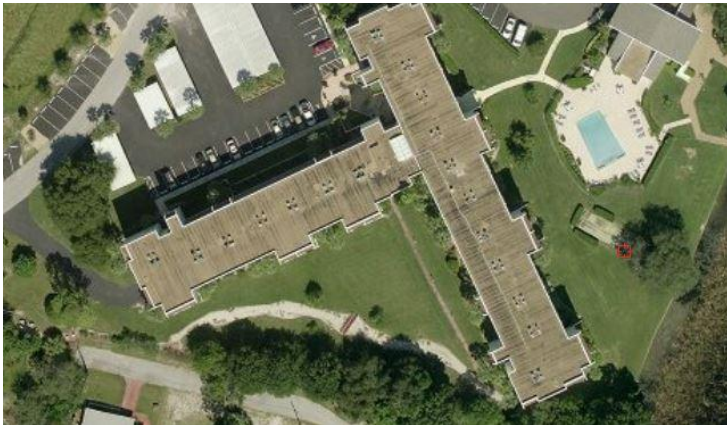
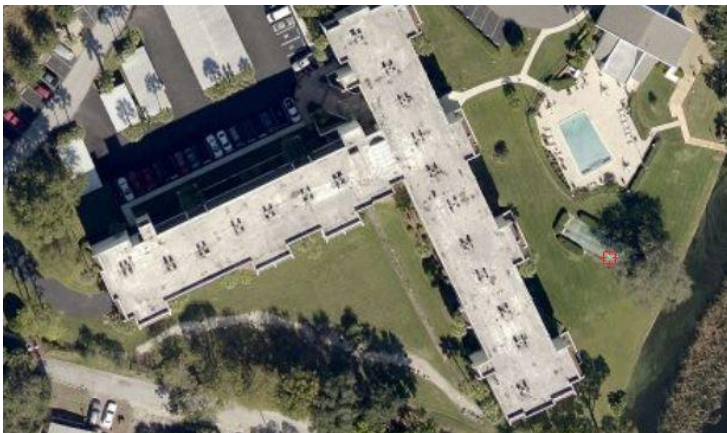
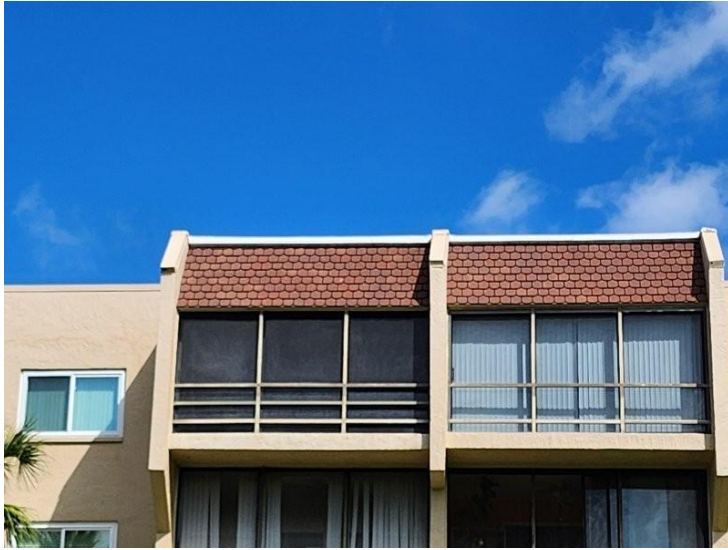
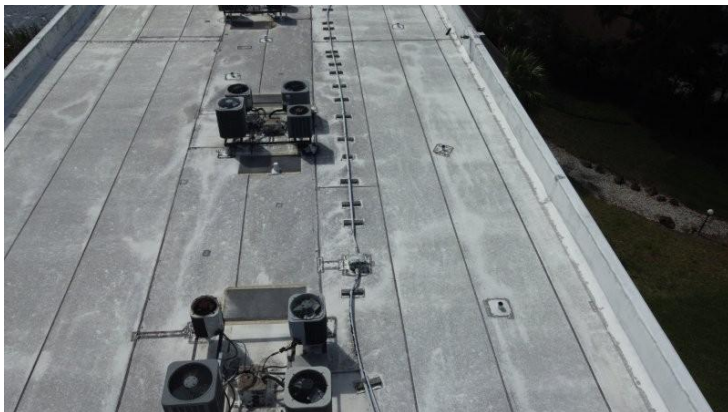
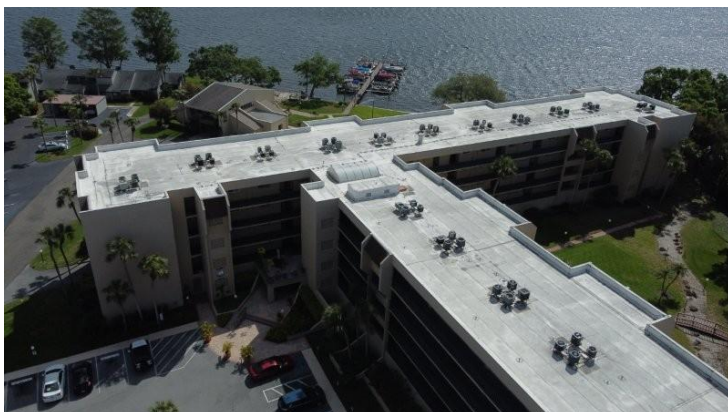
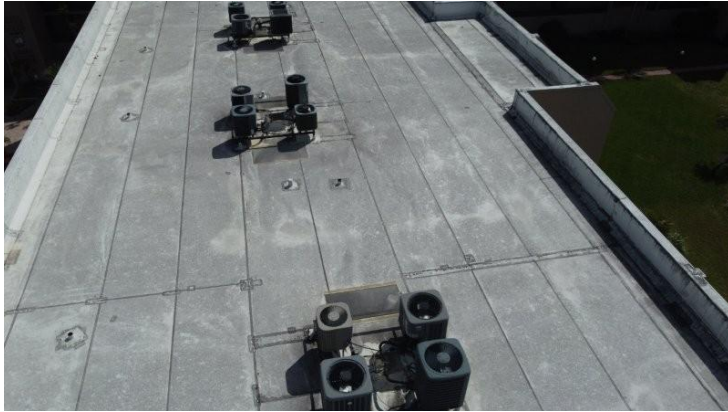
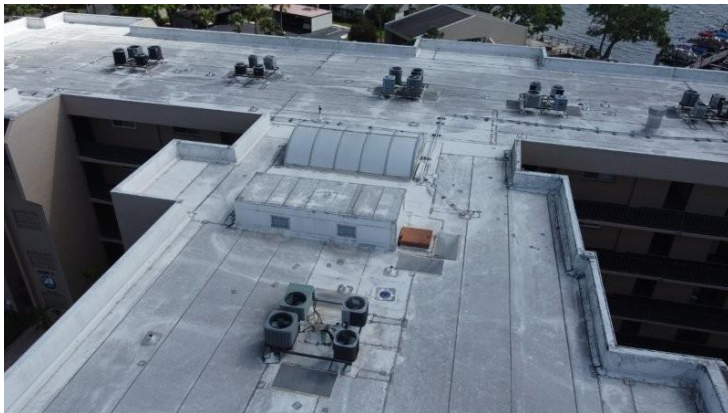
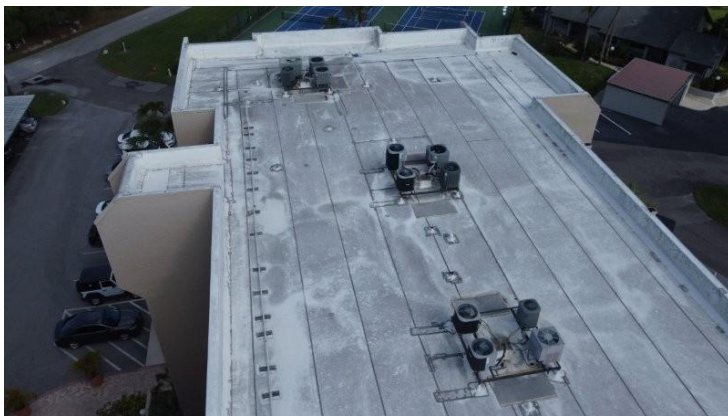
Roof Construction

Comments: | Reinforced Concrete Roof Deck
Inspection verified a roof structure composed of cast-in-place or pre-cast structural concrete designed to be self-supporting and integrally attached to the wall / support system. |

Comments: | Structural
Inspection verified a roof structure composed of cast-in-place or pre-cast structural concrete designed to be self-supporting and integrally attached to the wall / support system. |
